# Manhole Inspection Summary

Manhole # S47Y1\_008MH

**Location** Address: **1301 Chesapeake Ave.**

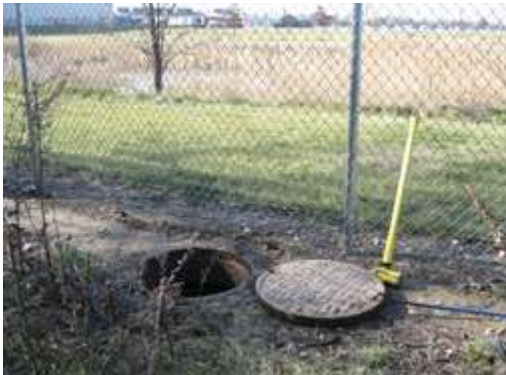
Location View

1301 Chesapeake Ave.

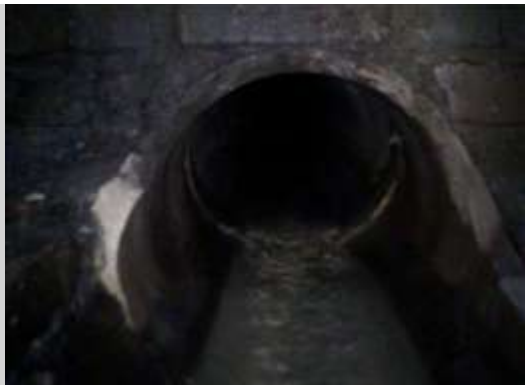
6 O'Clock Inflow

10 in. Circular Gravity Sewer  
Pipe In @ 6 O'Clock

Pipe Height: **10.8** (in.) Rod and Bar (Angled)  
Pipe Material: **Clay** ☐ Pipe Lined  
Invert Depth: **12.80** (ft.) Flow Characteristics: **Fast**  
Deposits: ☒ None ☐ Mud ☐ Sludge ☐ Debris ☐ Grease  
Silt Depth: (in.) Deposits Extent:  
Infiltration: **None** Pipe Seal Cond: **Sound**
